## Geographical condition and climate

# **Ruines**

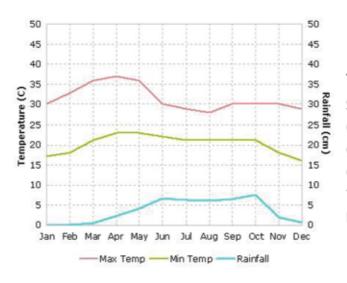
The graph shows the monthly number of sunny, cloudy, overcast and precipitation days. It is seen that from the month of January till mid of May the temperature is 35 degree and is sunny all day. Gradually the temperature decreases up to 21 degree in monsoon

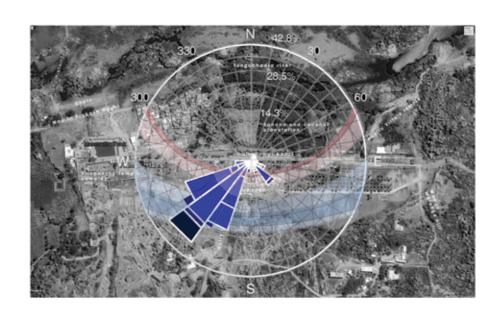
The wind rose for Hampi from South West (SW) to north east. This graph shows how many hours per year the wind blows from the indicated direction.

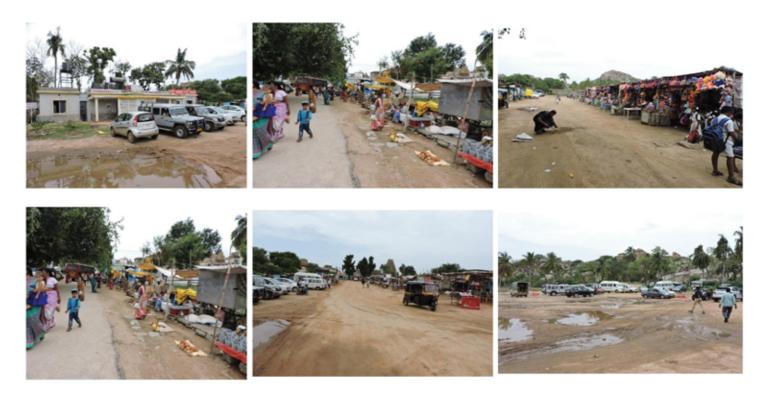
This parking area also serves the tourists with many facilities such as public toilets and drinking water facilities, small souvenir shops, eatery stalls. These are the temporary stalls and shops which are recognised as illegal by the Government. There are 76 stalls in this area.

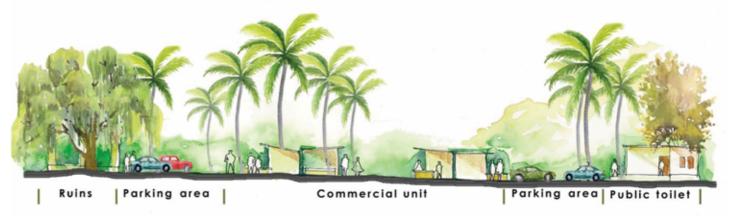
Along both side of the road there are small stalls or hawking activities which take place during the day time. Temporary commercial stalls have artefacts, bags, hats, metal and wooden sculptures for sale. The stalls also include fruit and vegetable vendors etc.

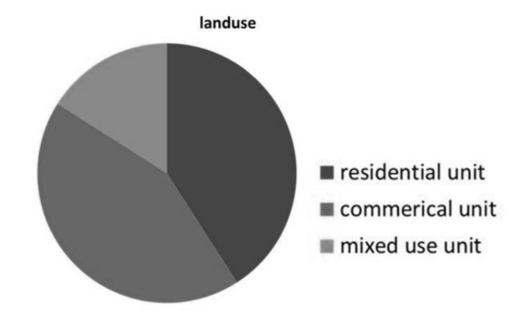
The main residential core of Hampi was the Virupaksha temple complex, with 151 families residing at Hampi. Total area built-up area of the settlement in 6331 sqm. Out of which 40.9% is purely residential, 43.08% commercial and with 16.02% is mixed used unit.

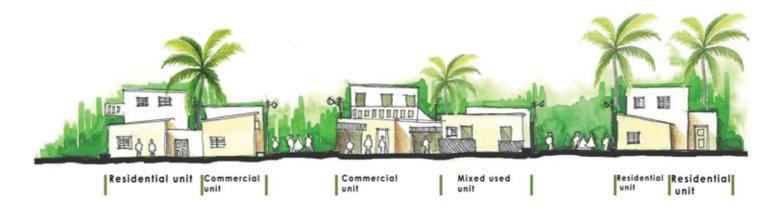
People residing in this settlement are living in the said plots from many centuries. There are more than 30 houses which are almost 45 years old, along with recently constructed houses. The massing of the settlement is in a way that lanes divide the locality after every four blocks, these are ground + one storied structures with mixed, residential and commercial units.
